NORTH FREMANTLE RAILWAY BRIDGE COLLAPSE 1926

An accident waiting to happen?

Heather Campbell

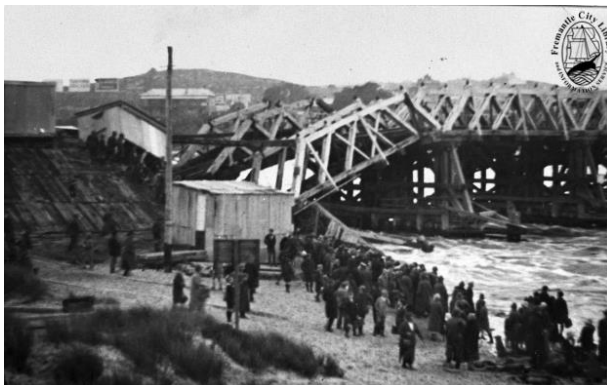
The North Fremantle railway bridge was sagging yesterday as a train passed over it. Shortly afterwards, when it was only by a miraculous piece of good fortune that there was no passenger train on it, the structure began to collapse, and the effect of the swirling flood waters soon put it hopelessly out of commission...

... Heralded by the rumble of loose sand and rocks falling into swirling water and the creaking and groaning of strained timbers, a considerable portion of the northern end of the railway bridge which spans the Swan River at Fremantle collapsed yesterday afternoon and was washed at a tremendous speed down the harbour and into the ocean by the flood waters of the river. That the disaster occurred without loss of life can be regarded as miraculous for, a few short minutes before the general collapse of the bridge took place a passenger train from Fremantle, bearing a human freight which included several children thundered over the weakened structure. After the train had passed, the condition of the abutments of the bridge was noticed and the alarm raised. Instantly railway officials at North Fremantle and Fremantle acted and all traffic between North Fremantle and the central station was suspended. This was done only just in time for a train from Perth was stopped as it entered the North Fremantle station a few minutes after the disruption of the bridge had commenced and a goods train out of Fremantle was signalled to stop at the junction leading on to the bridge on the south side. ... That the occurrence would prove a severe blow to the Port was generally recognised. It would mean, it was stated, that the southern side of the harbour was practically isolated as far as cargoes coming from Perth were concerned ... Although, yesterday, no announcement was made, it would appear that the majority of the vessels using the harbour in the near future will be berthed at the North Fremantle quay, the railway facilities of which have not been affected by the breakage of the bridge...

The collapsed Railway Bridge, 22 July 1926,
(Fremantle City Library Reference 3375)

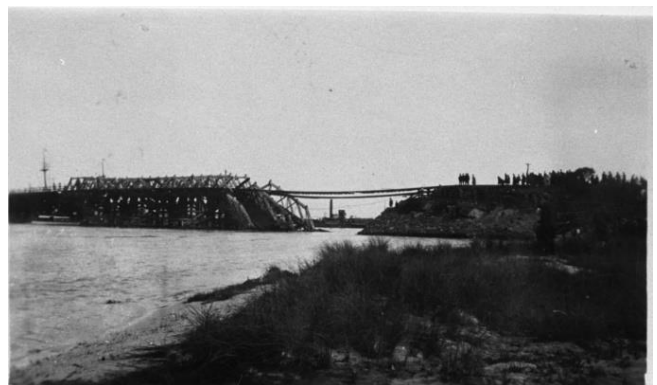
The collapse of Fremantle Railway Bridge, 1926
(Fremantle City Library Reference 3631)

The first sign that anything untoward was happening was a crack which appeared in the embankment. When this was noticed the damage had been done, for, as each wave lapped the stones the embankment was weakened more. Within a few minutes the bridge was damaged to such an extent that repair appeared impossible. A heavy mass of masonry gave way, and taking with it protecting timber, crashed into the water and was closely followed by beams from the bridge, which were left without support at one end. Through the gap thus created the torrent raged and it was only a matter of time before a gap of nearly 100ft. yawned between the bank and shattered end of the bridge. Throughout the afternoon pieces of timber cracked and fell, and in falling, weakened other timbers, which, in turn soon became the playthings of the river. Not only were the timbers of the bridge continually falling but the embankment, too, was eaten away. ...

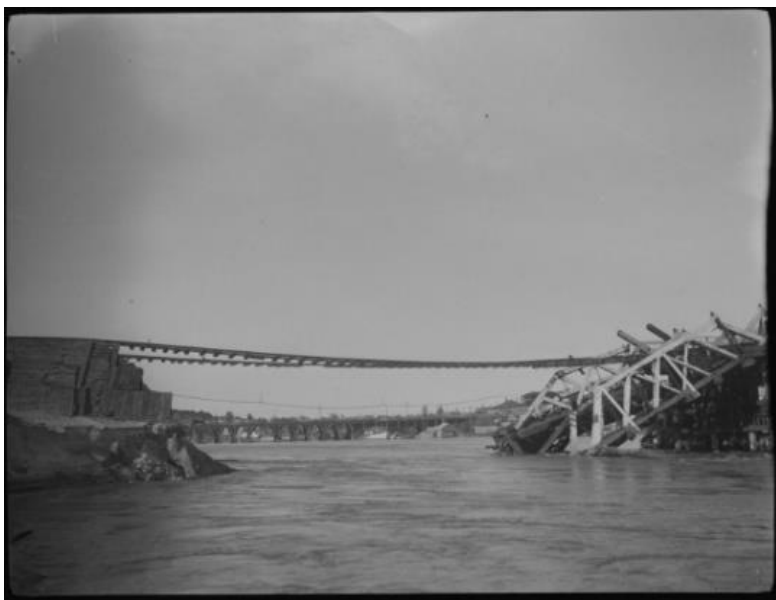
Fremantle Railway Bridge, collapsed
22 July 1926
(SLWA 217691PD)

... The first person to notice that anything was seriously amiss was Mr. George Henderson, master of the harbour tender Reliance [who] had noticed a slight crack in

the northern abutment on the previous day. At the time he did not regard the matter as serious, but when he inspected the spot again early yesterday afternoon he was perturbed to find that the crack had opened slightly. Whilst he was inspecting the fissure the 1.12 p.m. train passed over the bridge, and a few moments later he was horrified to see the gap open to a width of five or six inches. Conscious of the exceptional pressure of flood waters that were swirling against the embankment and the bridge supports, he realised that it would be only a matter of minutes before the aperture would be considerably widened, and a large portion of the abutment swept away. Instantly he clambered up the railway embankment and conveyed his startling tidings to a party of fitters who were working on the permanent way. Ganger Hogan, who was in charge of the party, acted without loss of time. He instructed a flagman to carry the news to the officials at the Fremantle station, and then set off to warn the stationmaster at North Fremantle. Prompt as was the action of Henderson, Hogan, and the workmen, their warning was not given a moment too soon. A goods train had actually left the Fremantle yards, and was approaching the bridge when a flagman arrived with the tidings that held it up and saved it from almost certain disaster. At North Fremantle the 1.5 [sic] p.m. passenger train from Perth arrived about 15 to 20 minutes after the alarm had been given...¹⁶

'The Minister for Railways visited the site and said that 'plant and material were already on their way for the repair of the bridge and that one line would be restored for traffic as soon as practicable...'¹⁷

By mid-October repair work was completed after several months of disruption to rail traffic¹⁸ and loss of trade for Fremantle businesses'¹⁹. Tests made 'with light and heavy engines combined' were 'quite satisfactory' and 'direct railway traffic from Perth and Fremantle' was re-established.'²⁰
